Murray-Ohio Dump Site Lawrenceburg, Lawrence County, Tennessee

**FY 2012 Remedial Action Priority Panel Briefing
EPA Spill #: 0496**

Murray-Ohio Dump Landfills

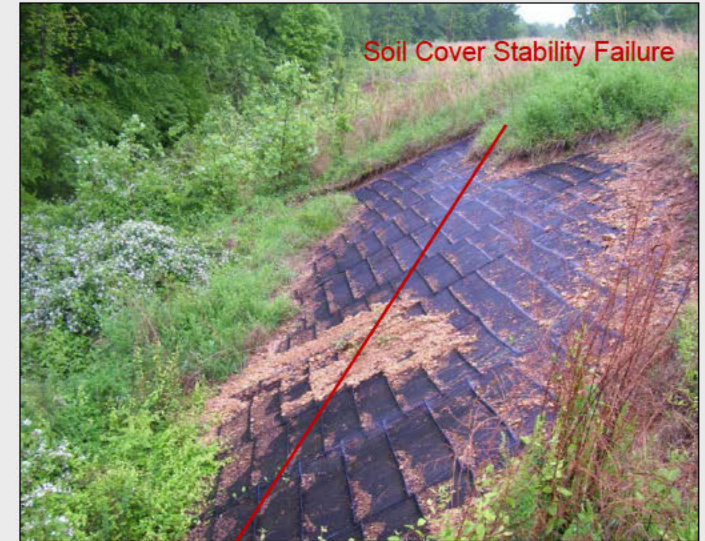
CHANNEL STABILIZATION AND CAP REPAIR AREAS/ SOIL COVER STABILITY FAILURE

- May 2011: Observed soil cover stability failure of the Cap (Gabion Area). Due to heavy rainfall events, head cutting is continuing and accelerating in the Overland Flow Area.

Cap Repair
Overland Flow Area

1. Phase 1: Includes channel stabilization to prevent a release from the Overland Flow Area and to repair the Overland Flow and Gabion Areas of the Cap

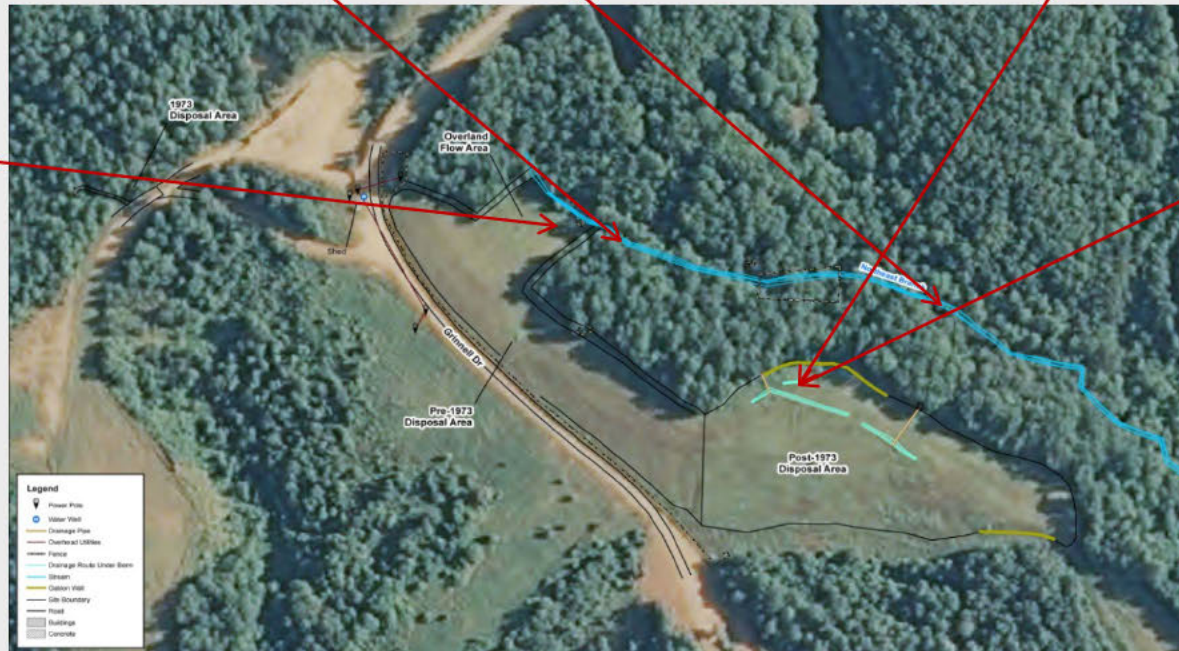
Cap Repair
Gabion Area

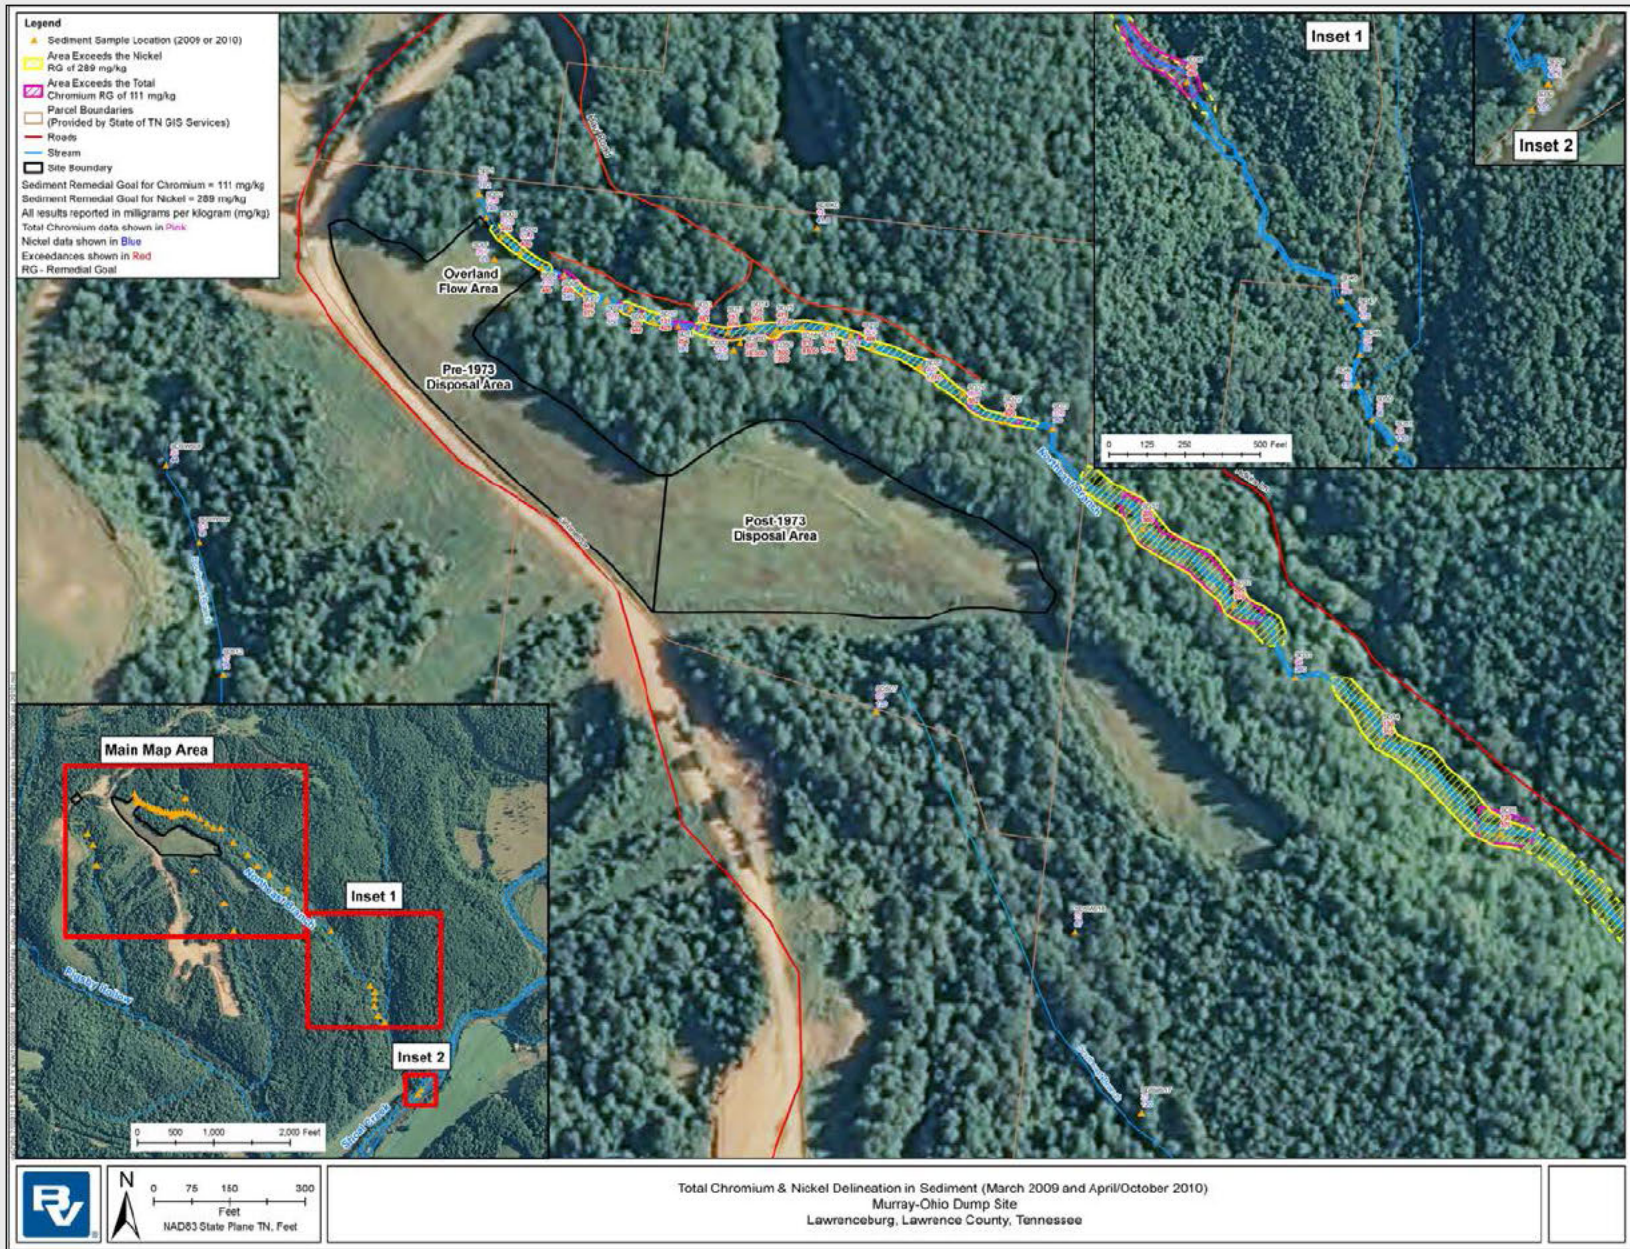
AREA OF CONTAMINANT REMOVAL IN THE NORTHEAST BRANCH

- Contaminated sediment removal in the Northeast Branch
 - In situ treatment of sediment, seep water, and surface water using constructed wetlands
 - Cap repair and continued monitoring of all media of concern
